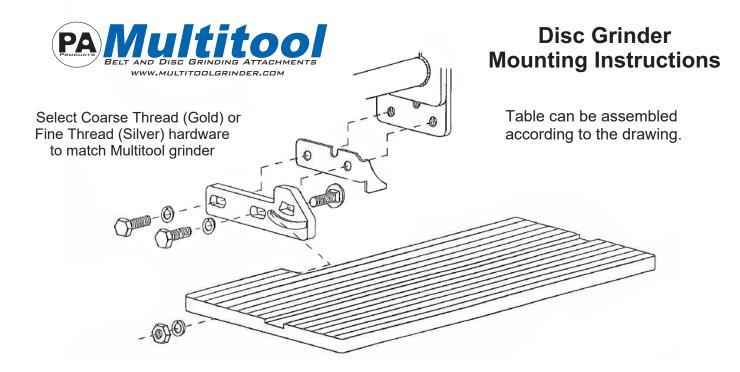
In some cases, the lower bolt for the Multitool tensioner arm interferes with attachment of the miter table mounting bracket. If that is the case, it will be necessary to add a second washer under the head of the tensioner arm lower attachment bolt. We've included this black oxide coated washer with the miter table hardware kit.

Fig: 1 shows the lower bolt for tensioner arm interfering with miter table mounting bracket .

Fig: 2 shows the black oxide coated washer installed in addition to the standard washer.
